Toxic and Hazardous  
Materials Agency

## Delivery Order 9 Enhanced Preliminary Assessment

**FORT DEVENS, MASSACHUSETTS**

April 1992

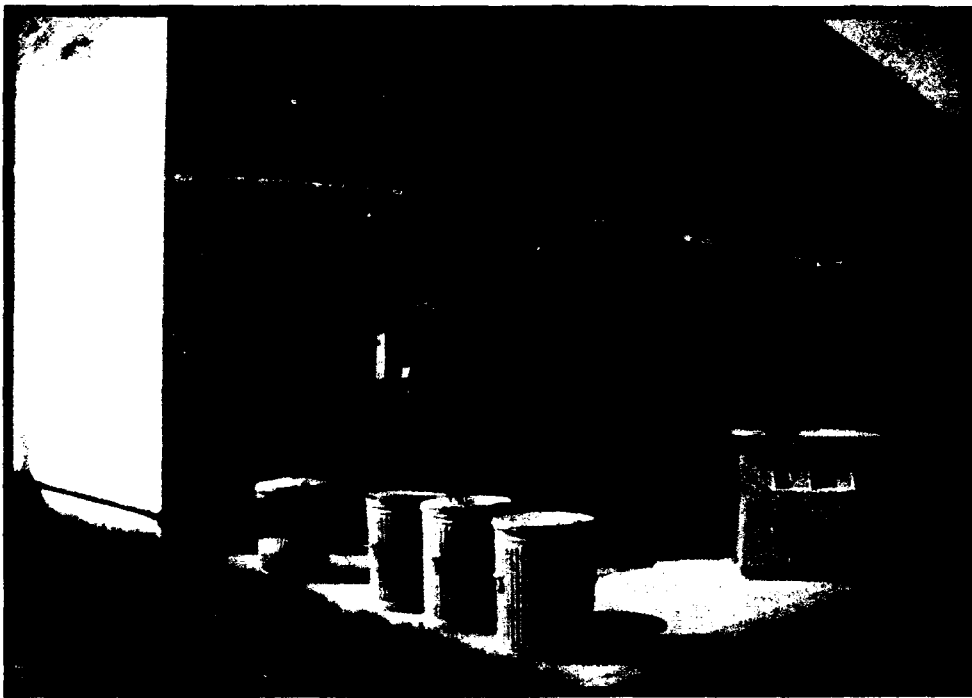
**1. AREE 1 - CUTLER ARMY HOSPITAL INCINERATOR**

As recommended in the MEP, a sample of the incinerator ash should be collected by Fort Devens personnel each time the ash is scraped out for disposal. A monthly composite sample should be analyzed for TCLP. Samples should be analyzed for radionuclides and dioxins semiannually. If, after 1 year, the results indicate a trend, then the sampling frequency can be changed accordingly, perhaps to semiannual or annual grab samples. If necessary, emissions testing may be conducted. When the unit will no longer be used, the ash should be removed and properly disposed of.

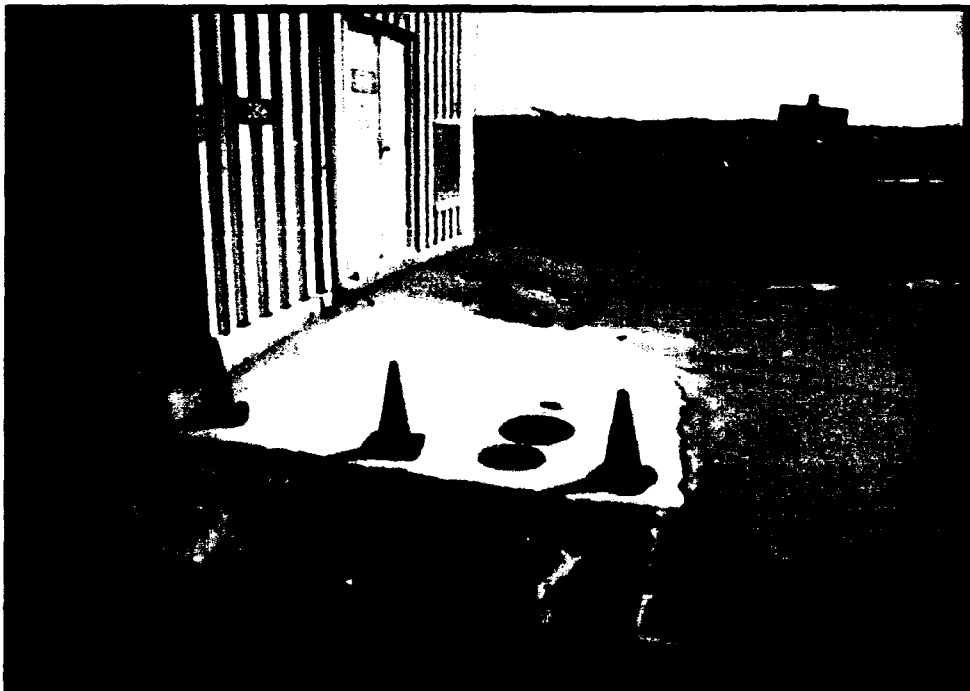
**19. AREE 47 - FORMER LUST SITE AT MAAF (BUILDING 3816)**
